TECHNICAL REPORT ARLCD-TR-82028

## EROSION RESISTANCE EVALUATION OF POTENTIAL GUN BARREL COATINGS

ARTHUR J. BRACUTI  
JOSEPH A. LANNON  
LOUIS A. BOTTEI  
ARRADCOM

FEBRUARY 1983

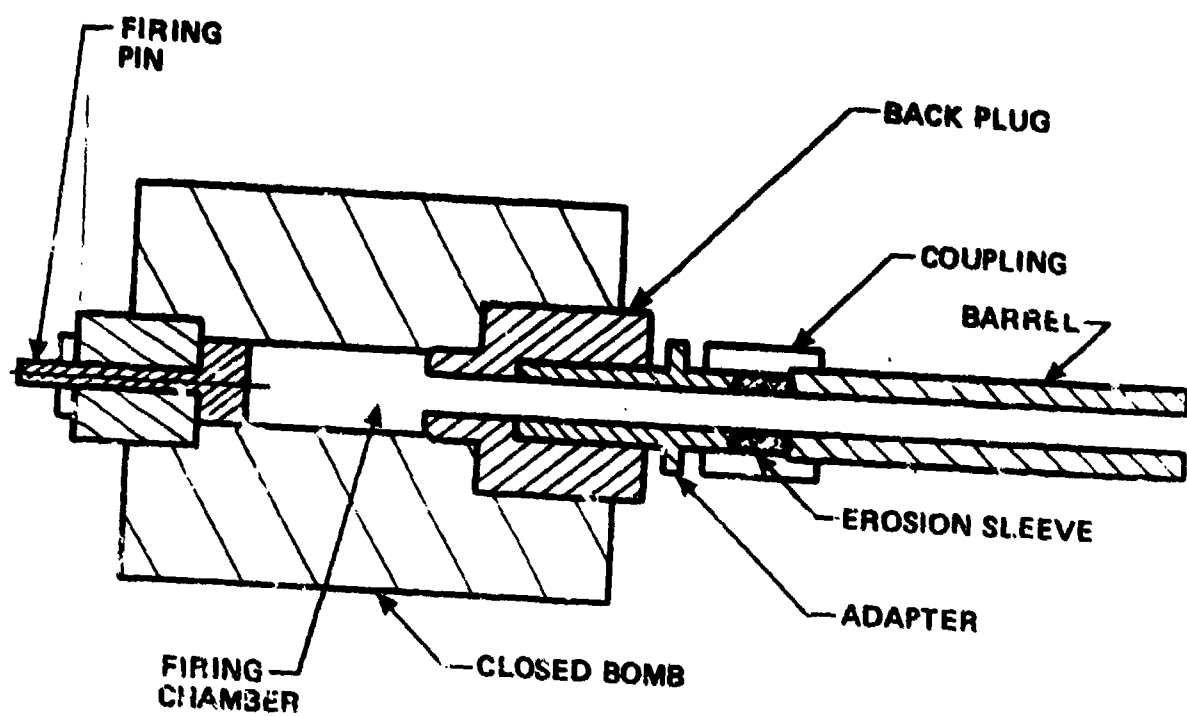
Figure 1. Erosion apparatus

The erosion data were obtained with a closed bomb modified to accept a gun barrel and a cylindrical metal erosion sleeve. This variation of the closed bomb is usually referred to as the vented erosion tester and is shown in figure 1. In this investigation, the erosion sleeves consisted of AISI 4340 steel, refractory metal coated AISI 4340 steel, and refractory metal coated molybdenum. Each sleeve was fabricated to have an outer diameter of 2.70 cm, an inner diameter of 0.95 cm, and a length of 2.06 cm. The average masses of the steel and molybdenum erosion sleeves were 80 g and 103 g, respectively. A pressure transducer positioned inside the chamber (closed bomb) was connected to a Nicolet digital oscilloscope which was scaled to display pressure versus time. To control pressure, a stainless steel rupture disc was inserted between the barrel and the erosion sleeve. In addition, the barrel was filled with water and a rubber stopper inserted into the muzzle to insure proper pressure buildup.
